# Crystal Lake Public Library 2022 Capital Maintenance Plan

## Executive Summary

Near and long-term repair and replacement needs for the Library were reviewed in light of the 2019 Strategic Facilities Plan (SFP), recent renovations, and current condition of the building by a team of architects and engineers. The collected data was compiled and filtered into two sets of recommendations based on whether the Library can follow through on the SFP. That plan calls for relocation of library services to a new building by 2030.

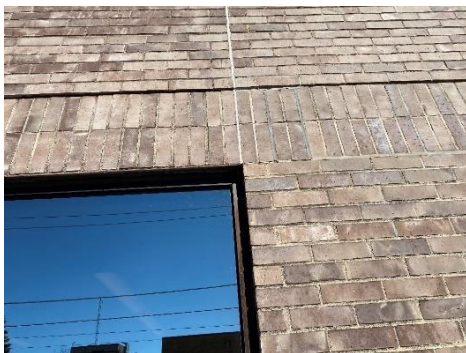
Figure 1  
Mortar joint repair example location

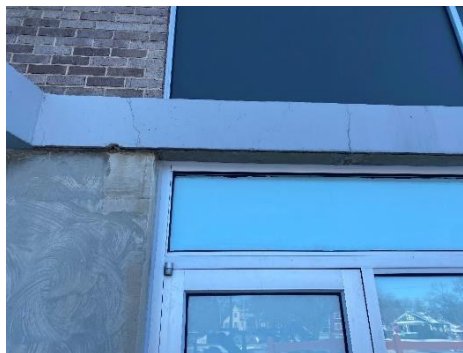
Figure 2  
Concrete base cracking example at 1965 Building

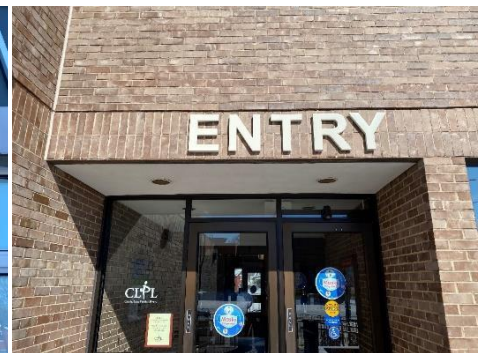
Figure 3  
Steel lintels to be cleaned and painted
